# Village-Wide Drainage Infrastructure Assessment

## Village of Pelham Manor Westchester County, New York

May 2023

*AI Engineers, Inc.,  
Dolph Rotfeld Engineering Division  
570 Taxter Road  
Elmsford, NY 10523*

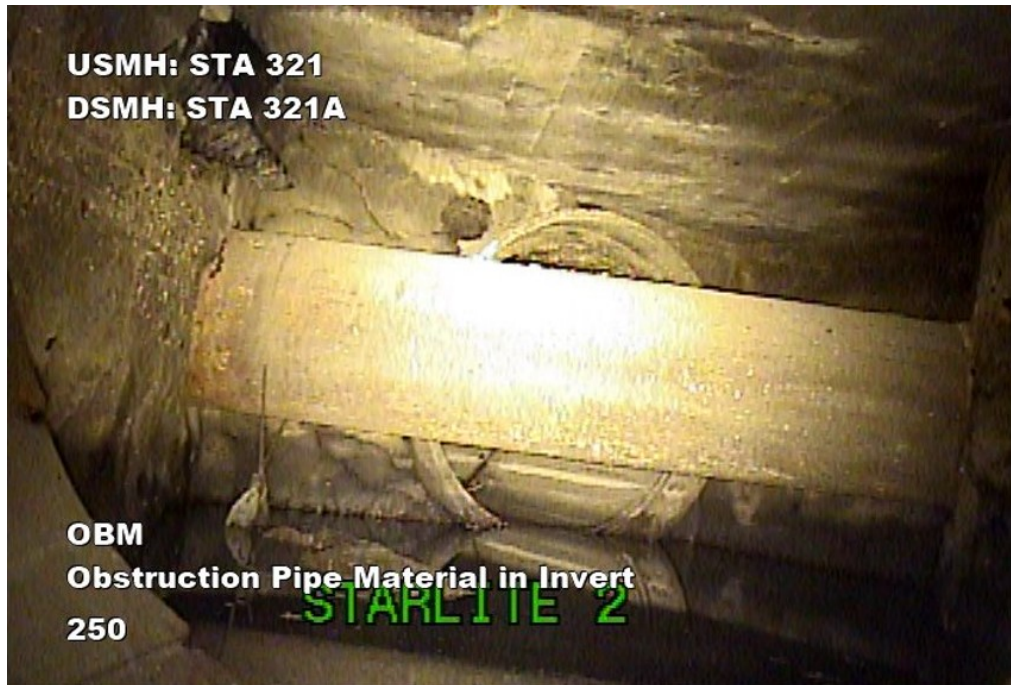
- CCTV inspection revealed a pipe interference within the drain manhole just west of the Hutchinson River Parkway and within the fringe of Glover Field. A 20” diameter sanitary sewer main passes directly through the drain manhole creating a blockage in the flow path. This condition has been incorporated in the SWMM model to evaluate the capacity with and without this blockage.

- Limitations due to the pipe interference and high water within the pipe under Glover Field made it impossible to sufficiently inspect the piping west of the sewer interference. However, record drawings of Glover Field and a previous CCTV inspection reveal that the piping is 48” in diameter and that at least one neoprene check valve has been installed by the Pelham Public School District to prevent backwater into the field. This should be verified when access to the drain manholes in Glover field can be accommodated.

- I. Further investigate and explore options for the removal of the sanitary sewer interference at Glover Field. *The SWMM models demonstrate that this obstruction causes a hydraulic jump and surcharging of the system in the Wolfs Lane area.* In order to remove this interference, either the drain line or the sanitary sewer line would need to be relocated. This would require additional survey and mapping of the existing sewer and storm drain to evaluate if this is practically feasible. Another

option may be to design a larger chamber at the interference/crossing that would effectively minimize the negative hydraulic effects of the interference, thus leaving the piping at its current alignment. Currently ownership and access rights are unclear in this location and should be investigated. Access to the drain manholes is under the turf field and would require coordination with the Pelham Public School District for inspection, this should be the next step along with verifying the 48" pipe sizing in this location. The sanitary sewer main conveys sewage from not only the Village of Pelham Manor but also the Village of Pelham and the City of New Rochelle, connecting across the Hutchinson River to the Pump Station owned by the Westchester County Department of Environmental Facilities located behind the "Ice Hutch" in Mount Vernon, so any remediation could involve multiple municipalities.
